VIM work on the Reed farm house

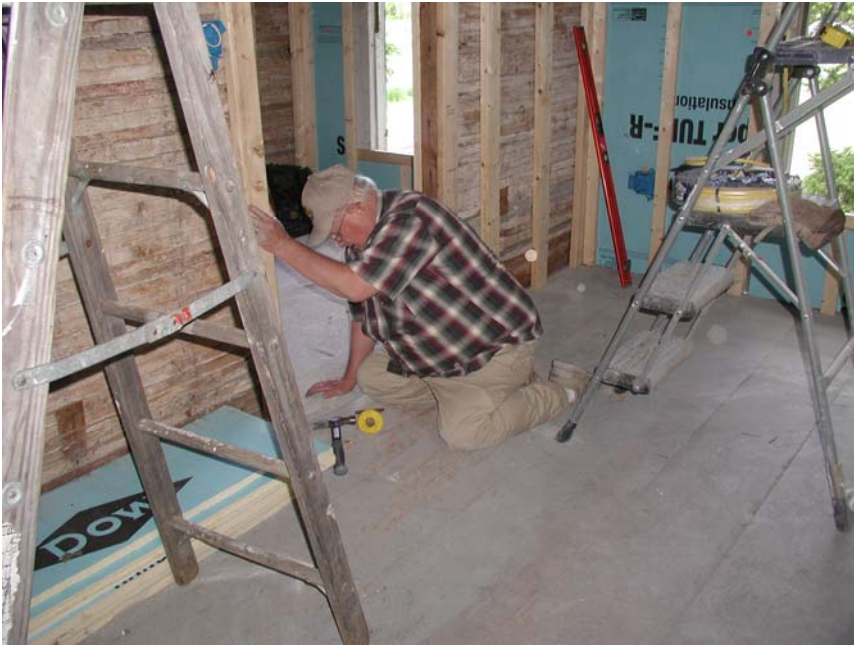
Three months ago a fire destroyed the upper half of the original home and some of the cedar shake roofing shingles under the slate roof of the 1840 main house. While fire did not damage this portion of the home, it suffered severe water damage. The lath and plaster walls and ceilings of the entire house had to be removed, 2x4 furring installed to level walls, rewire, insulate and new sheetrock.

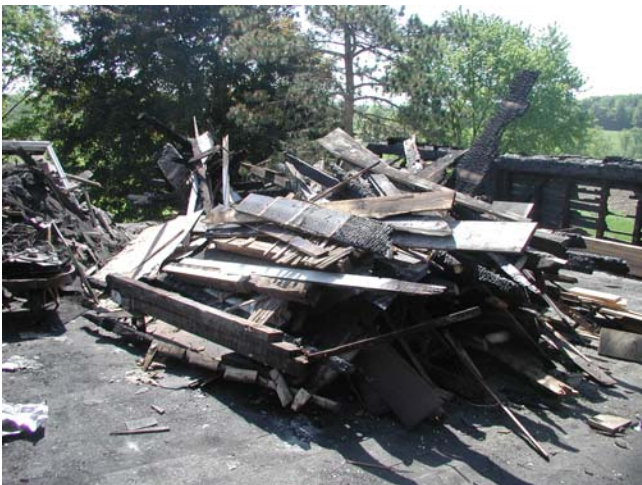
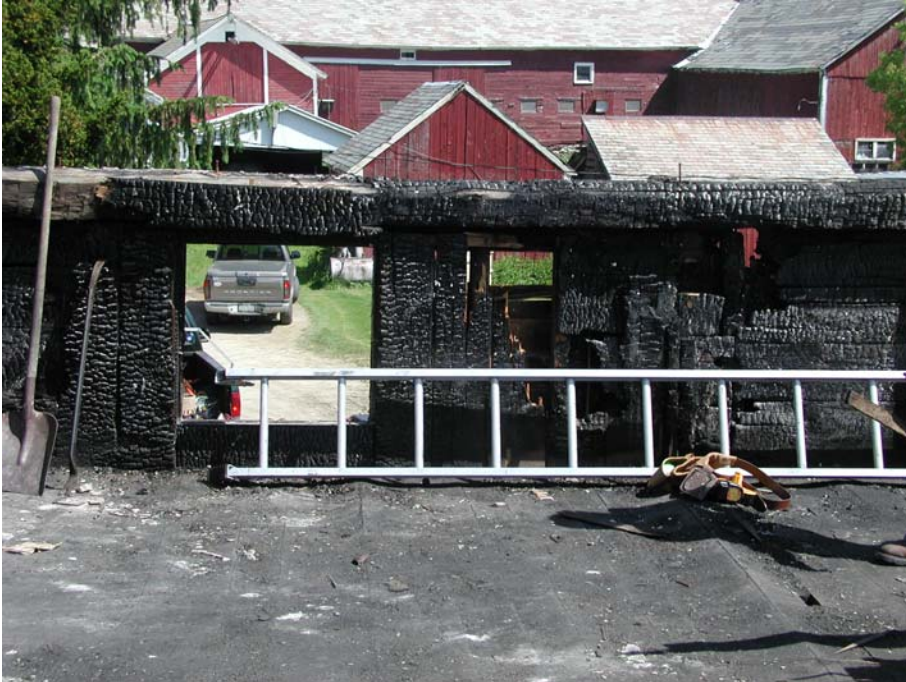
The 1820 portion of the house needed all the burned debris tore down and removed before construction of the new roof could begin.

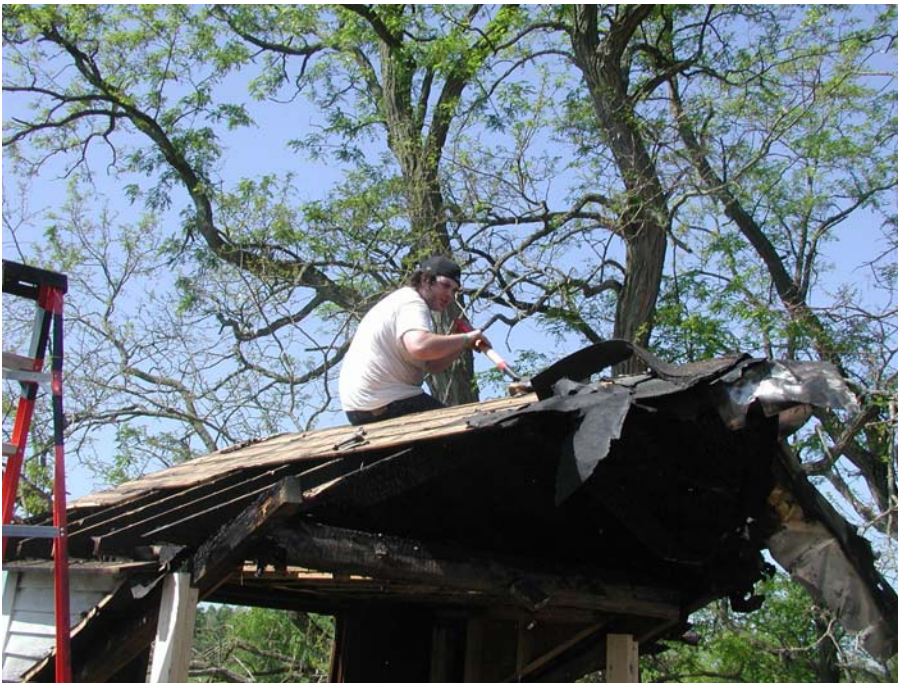
We were able to save a small dormer but it had to be supported and cleaned of all burnt material.

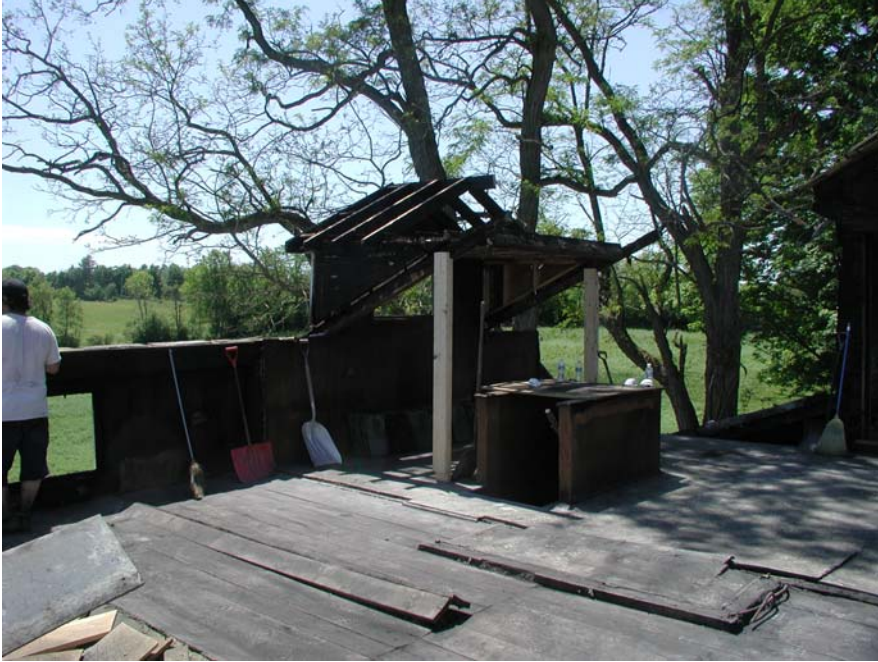
The floor boards are so warped it is imposible not to trip.

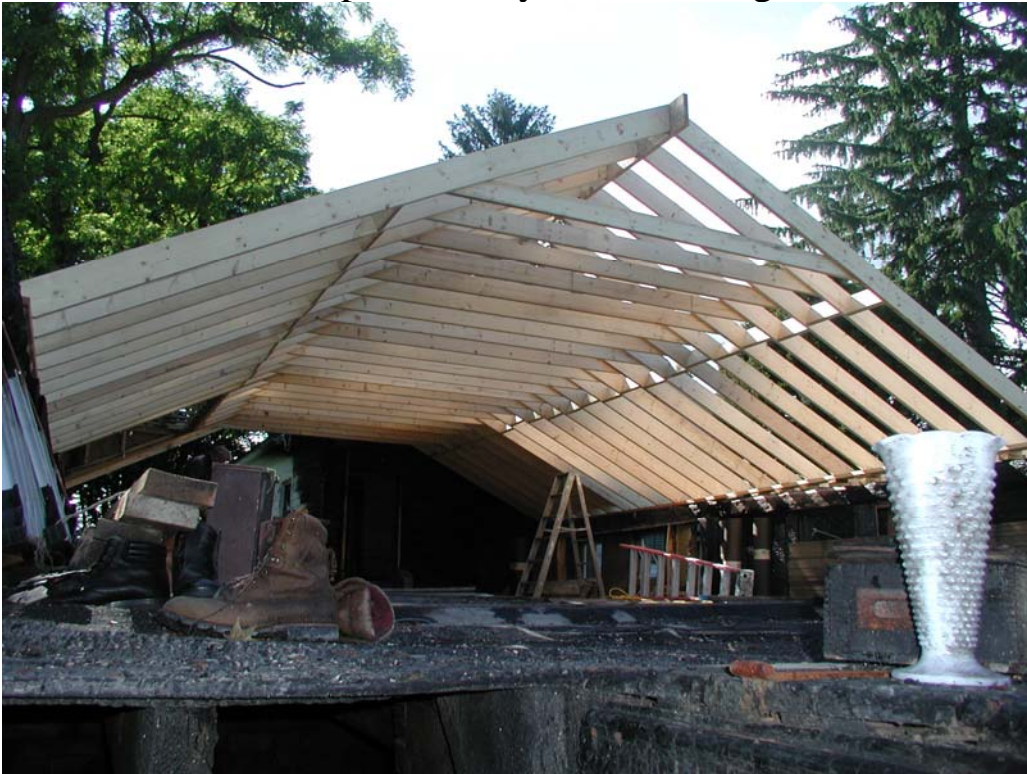
All the trusses are up and ready for sheathing.
