VIM work on the Reed farm house

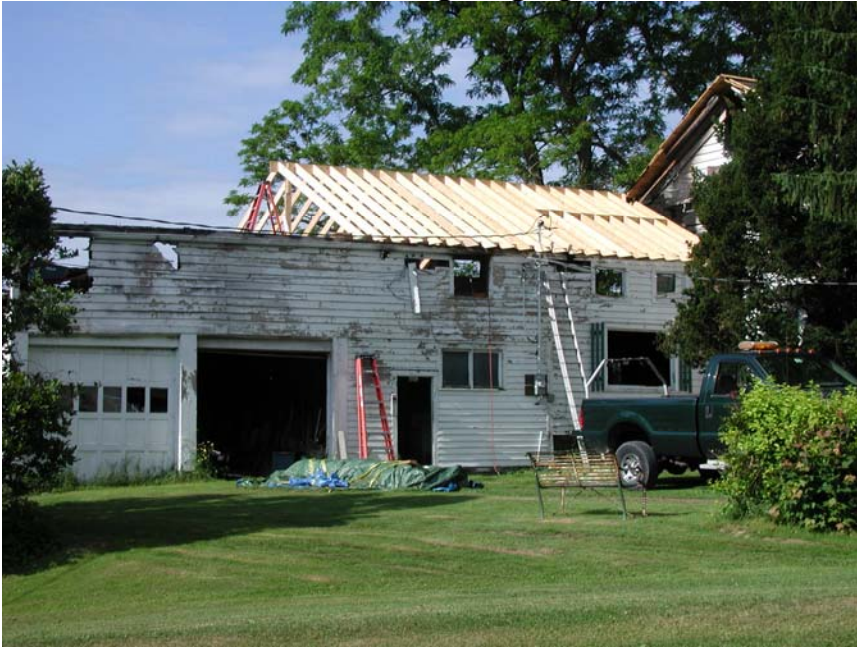
In 1820 the original post and beam house was built. It was half house and half barn. The garage portion will be removed.

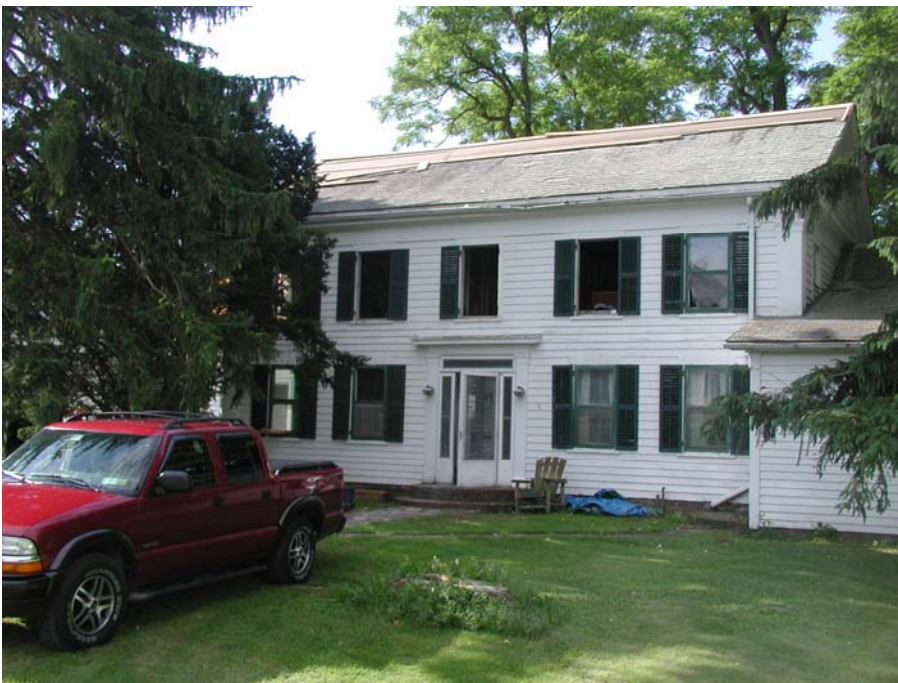
As Mr. Reeds Great Great Grandfather's family grew to 10 they had need for more bedrooms and put a big addition on in 1840.
